Assessment of the Functional Performance of Mohammed Al-Qasim Expressway Pavement Surface

Abstract

Keywords: Mohammed Al-Qasim Expressway; Pavement distress; Functional performance; Pavement Condition Index (PCI).

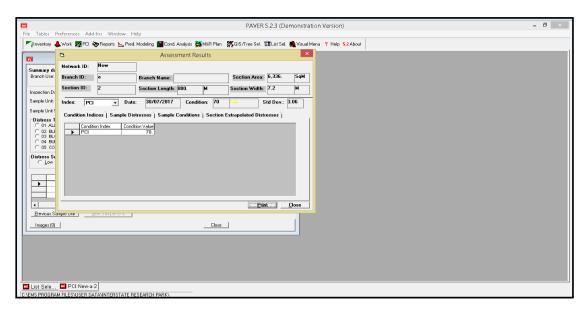
Figure (4) PCI for AC Pavement Surface

PCI value for AC pavement surface is equal to 70 as it is presented in figures (4) and (18). The condition of pavement is rated as fair as mentioned in ASTM D6433-07 due to several causes of distress. Some of the distress related to traffic load (Cracks for example) represents the ratio equals to 13%. While 87% of the distress is due to the climate condition such as weathering. Figure (18b) exhibits some of the distress types observed on AC pavement surface, including alligator crack (Alligator CR), longitudinal crack (Long. CR) and rutting in the right lane as well as longitudinal and transverse joint reflection cracks (JT REF.CR) at both right and middle lanes.

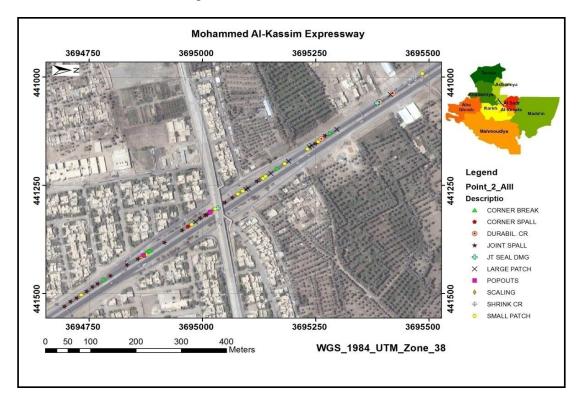
Figure (12) Distress Types in Transverse Tining PCC Pavement Surface

Figure (19b) shows some of the distress types that have been observed on the PCC pavement surface, such as large patching, corner break, shrinkage crack, map crack and joint spalling in the middle lane with varying severity levels, and some low patching, corner break and joint spalling at right lane.

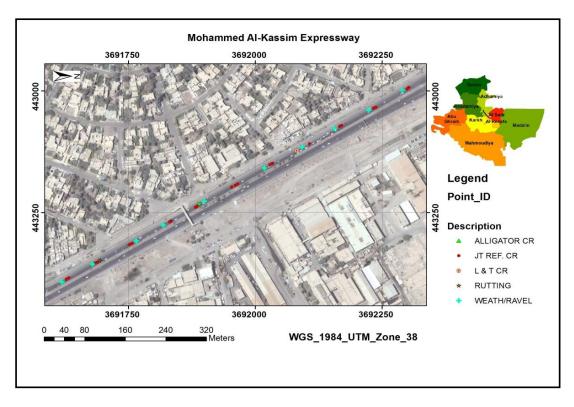
Figure (13) Distress Types in AC Pavement Surface

- 3. Five types of distress are observed on AC pavement surface; they are alligator crack (Alligator CR), longitudinal crack (Long. CR) and rutting in the right lane as well as longitudinal and transverse joint reflection cracks (JT REF.CR) at both right and middle lanes.

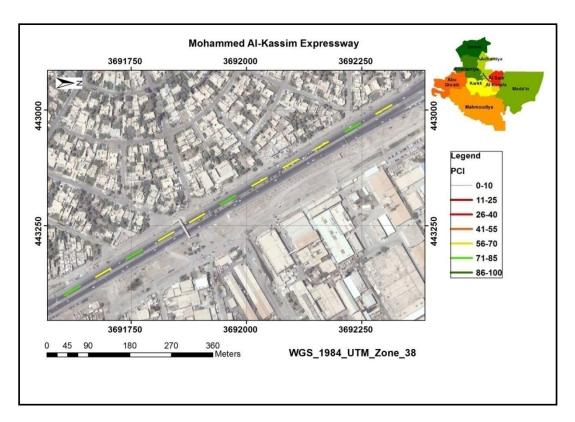
Figure (20) AC Sample Units in GIS Program with PCI Range Color Suggested by ASTM D6433-07

From figure (20), it can be observed that out of the eleven examined sample units only seven units are rated as fair while others are rated as satisfactory for AC pavement surface. AS for transverse tining PCC, one the sixteen examined sample units rated as fair. In addition, two sample units are rated as poor while the remaining are units are rated in satisfactory and good condition as it is shown in the figure (21).
